Turning the tide on typhoon damage in the Philippines

Road rehabilitation in a mountainous agriculturally rich area of Philippines tries to counteract effects of cyclones and man made slope degradation.

Gareth Hearn
& Jonathan Hart
Scott Wilson
Kirkpatrick & Co Ltd
gareth.hearn@scottwilson.com
www.scottwilson.com

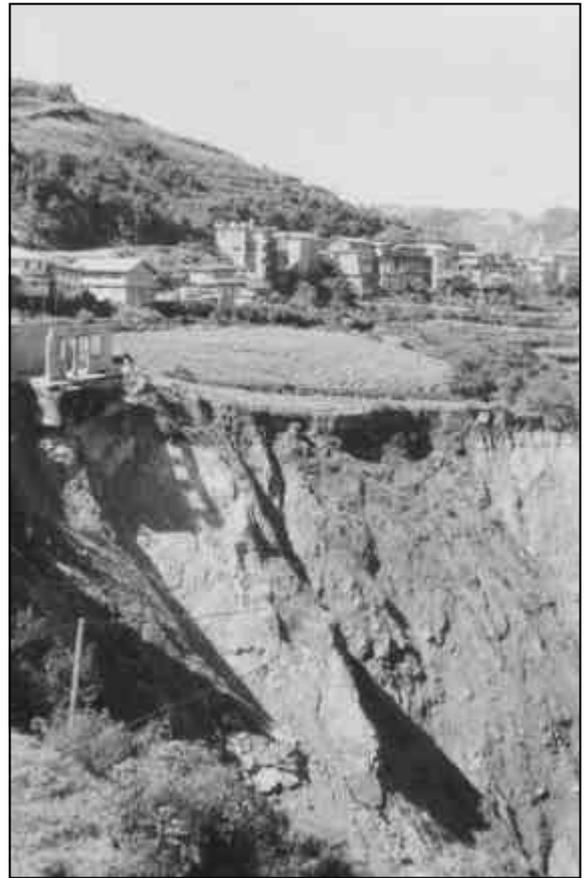
Erosion causes damage to buildings and agricultural land

The region was extensively damaged by an earthquake in 1990, measuring 7.8 on the Richter Scale, followed the same year by a succession of typhoons and intense rainstorms. There was pervasive damage to the slopes and the Halsema Highway, which links Baguio with the agricultural hinterland to the north, was destroyed in several places. In 1997, the road was closed for 6 weeks while landslide damage caused by intense typhoon rain was repaired. The impact of these road closures on the local economy was highly significant. More recently, over 1 metre of rain was recorded in a single 24 hour period in Baguio during Typhoon Feria in 2001. Because of the steeply sloping ground, this rainfall inevitably runs off the hillsides causing erosion and damage to farmland and engineering structures.
